# HARDWARE PATCH for Zemmix Neo, SX-1, SM-X and related machines ( update 2020.04.06 )

## 2020.08.19 Hardware Patch for OCM machines “aka BUSDIR\_n patch”

## 2020.10.16 Hardware patch for Zemmix Neo BR machines (aka +5V line stability fix)

# 2022.06.02 Hardware Patch for SM-X, SX-2 and related machines

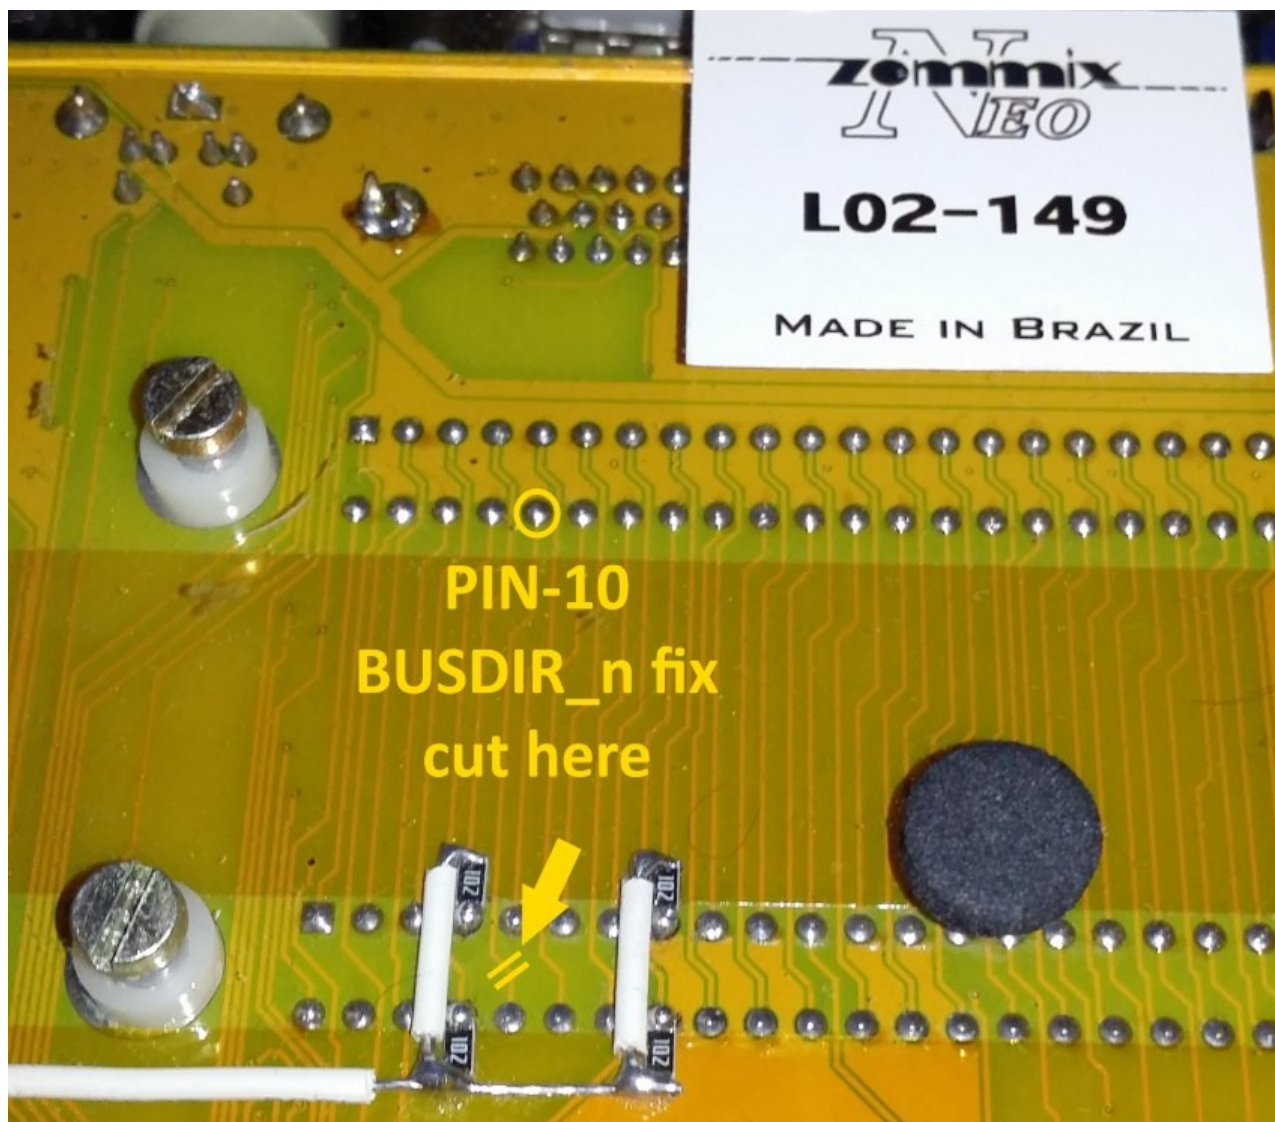
- In OCM machines we have a short circuit between pin-10 (BUSDIR\_n) of the two external slots that continues towards the FPGA. This type of connection confuses some cartridges.
- While the Panasonic FS-A1ST and Canon V-20 service manuals confirmed that the BUSDIR signal is not used.

- Pin-10 (BUSDIR\_n) of the external slots must be isolated.

- Method 1 - Cut the track that connects pin-10 of Slot-1 and Slot-2 leaving unchanged the connection to the FPGA already internally isolated by the firmware.
- Method 2 - Desolder pin-10 of slot-2 from the PCB and insulate it with the sheath of an electric wire and a drop of hot glue.
- Method 3 - Place non conducting tape over pin 10 of those cartridges that are not working properly, such as MoonSound and Darky.

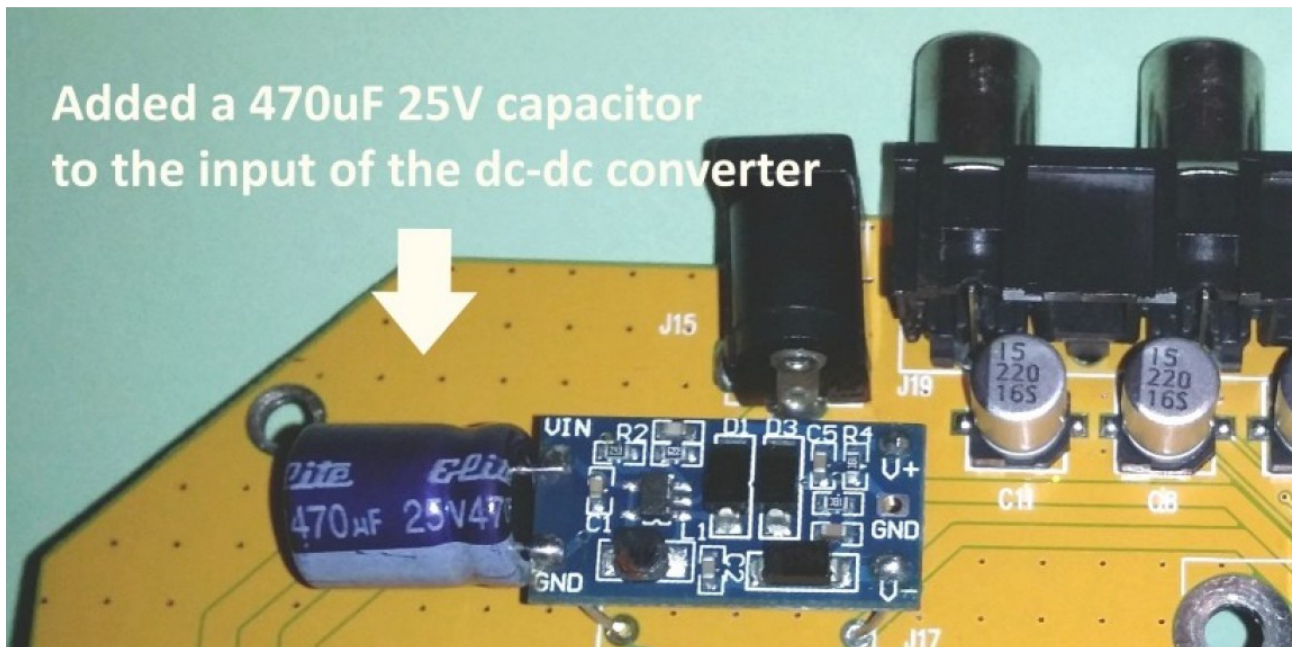
Based on the wiring diagram of the original 1chipMSX machine, I have implemented this new hardware patch for Zemmix Neo Brazilian which allows to stabilize the +5V input line. This patch can for example remove some annoying video interference on the output of GFX9000 and other similar cartridges. Please be informed that the problem is currently only present on Zemmix Neo Brazilian and not with Zemmix Neo Korean, but this fix can still be used if your hardware is unstable.

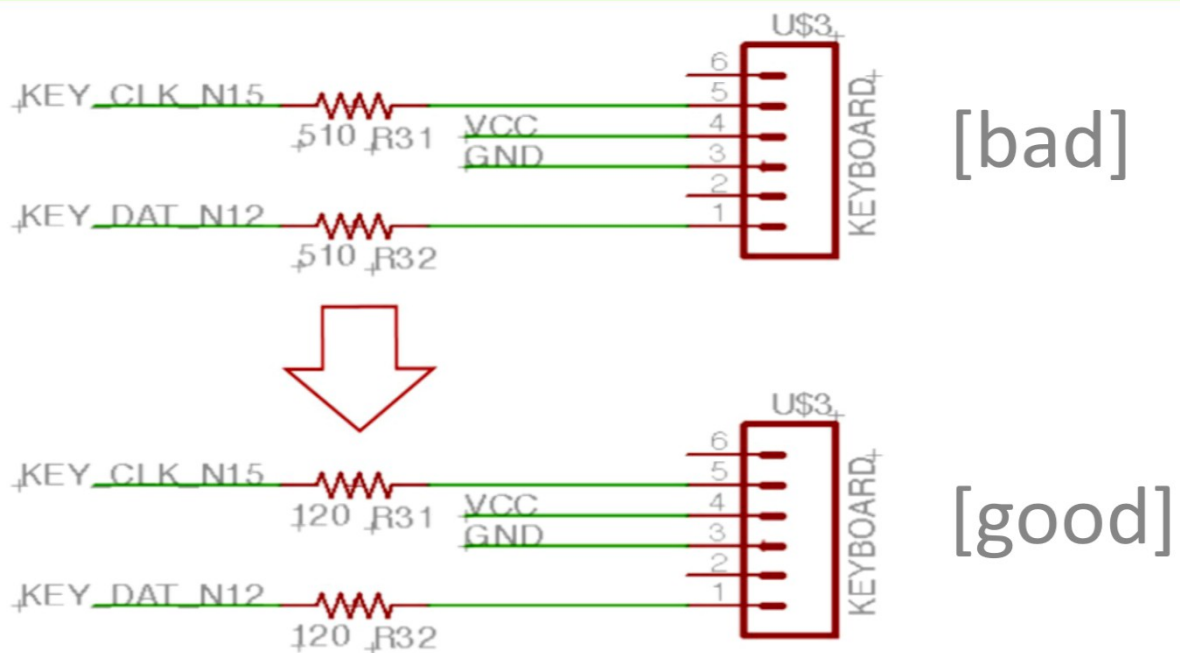
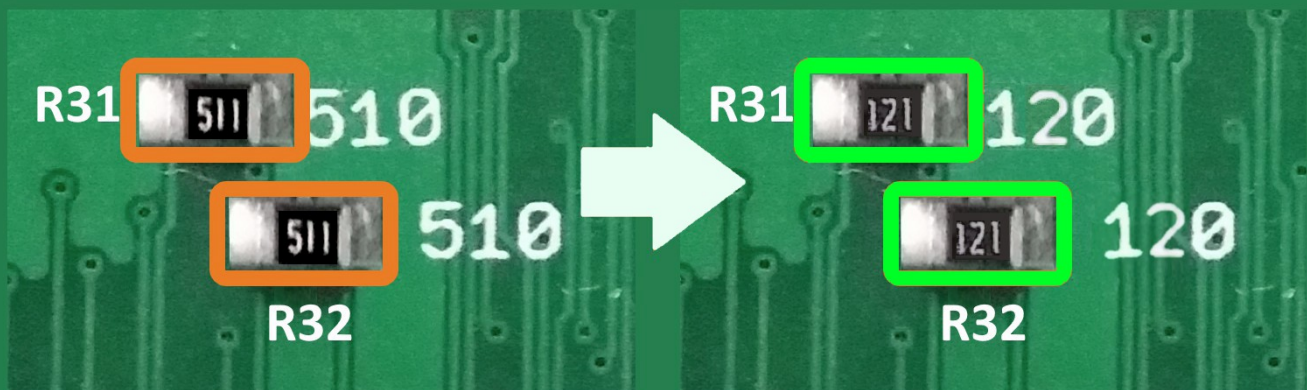
(aka PS/2 keyboard compatibility fix) [ Revision 2 ]

**How to do it: replace the resistors  
R31 and R32 with a value between 120  $\Omega$  and 390  $\Omega$ .  
A value of 120  $\Omega$  is recommended to ensure maximum compatibility.**

**This is an optional fix. If your keyboard is NOT working properly  
you can apply this hardware patch or purchase another keyboard.**
