# HARDWARE PATCH for Zemmix Neo, SX-1, SM-X and related machines ( update 2020.04.06 )

## 2020.08.19 Hardware Patch for OCM machines “aka BUSDIR\_n patch”

## 2020.10.16 Hardware patch for Zemmix Neo BR machines (aka +5V line stability fix)

# 2022.06.02 Hardware Patch for SM-X, SX-2 and related machines

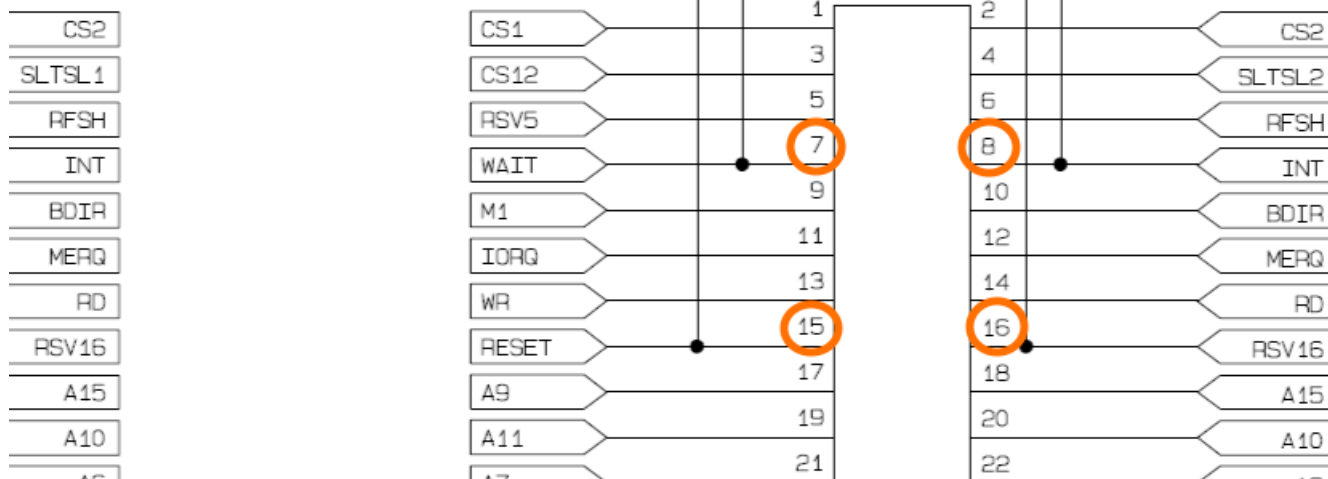
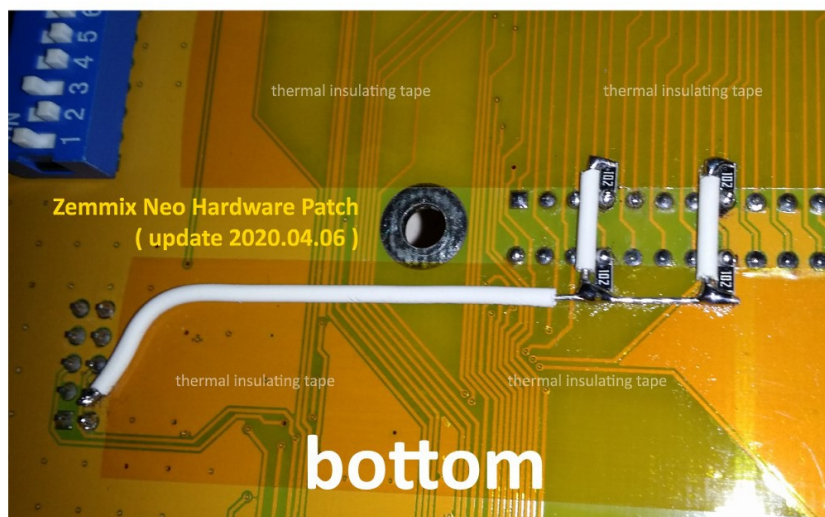
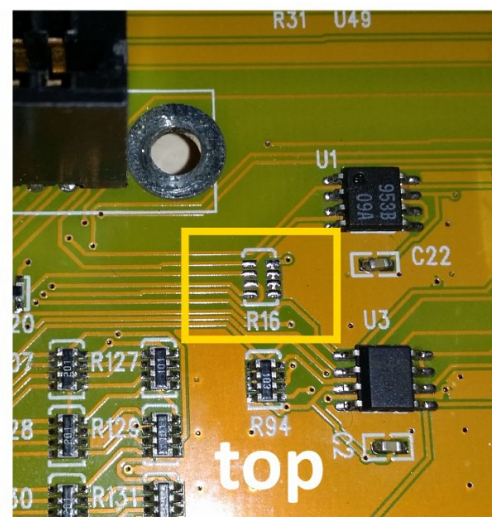
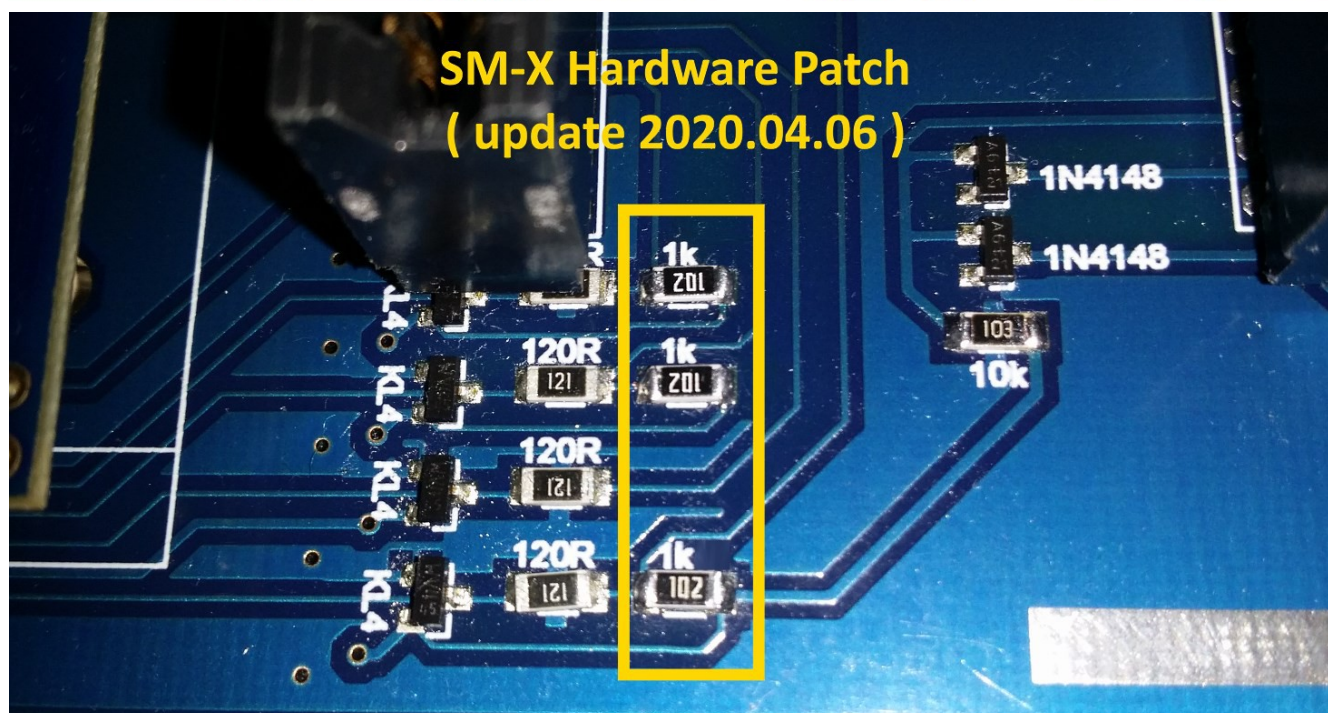
- In OCM machines we have a short circuit between pin-10 (BUSDIR\_n) of the two external slots that continues towards the FPGA. This type of connection confuses some cartridges.
- While the Panasonic FS-A1ST and Canon V-20 service manuals confirmed that the BUSDIR signal is not used.

- Pin-10 (BUSDIR\_n) of the external slots must be isolated.

- Method 1 - Cut the track that connects pin-10 of Slot-1 and Slot-2 leaving unchanged the connection to the FPGA already internally isolated by the firmware.
- Method 2 - Desolder pin-10 of slot-2 from the PCB and insulate it with the sheath of an electric wire and a drop of hot glue.
- Method 3 - Place non conducting tape over pin 10 of those cartridges that are not working properly, such as MoonSound and Darky.
